AIRCRAFT ACCIDENT INVESTIGATION REPORT

Japan Air Lines Co., Ltd.
Boeing 747 SR-100, JA8119
Gunma Prefecture, Japan
August 12, 1985

Aircraft Accident Investigation Commission
Ministry of Transport

June 19, 1987

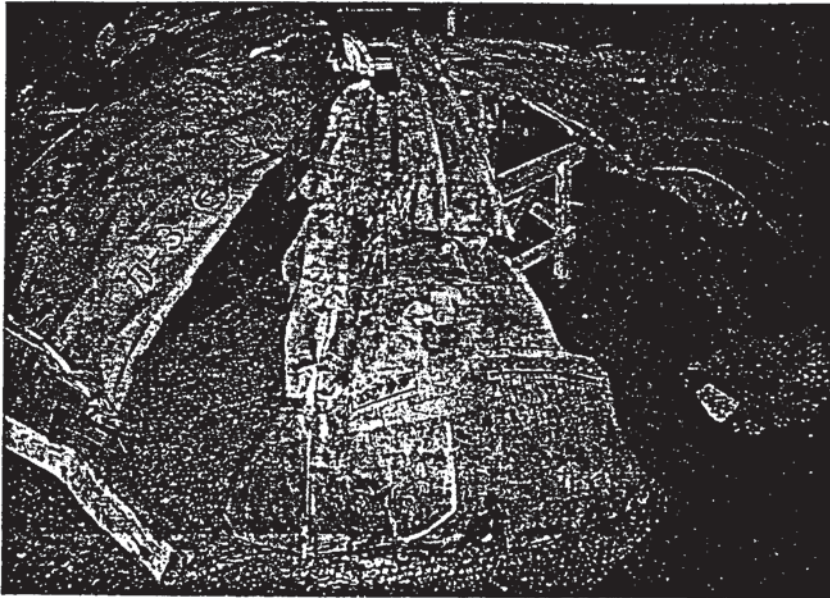
66 Aft pressure bulkhead part 2 (pressurized side)

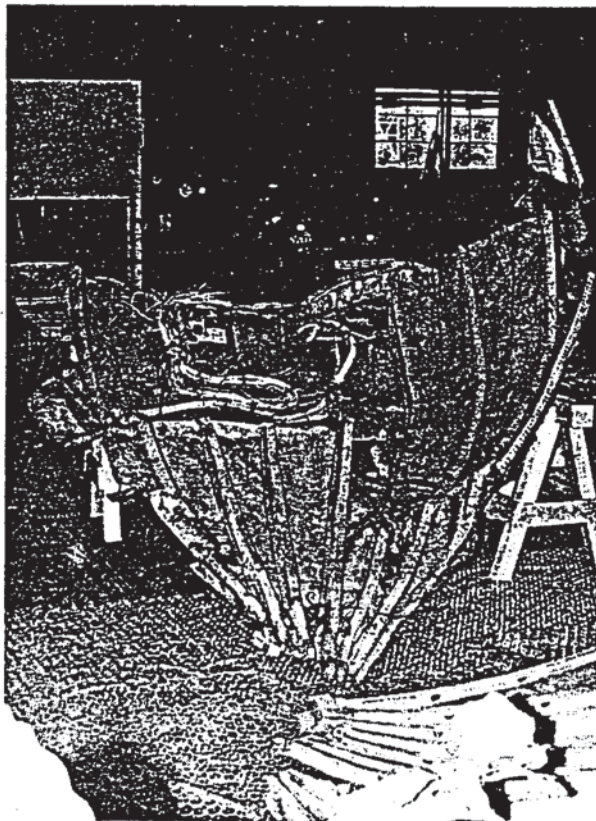
67 Aft pressure bulkhead part 2 (nonpressurized side)

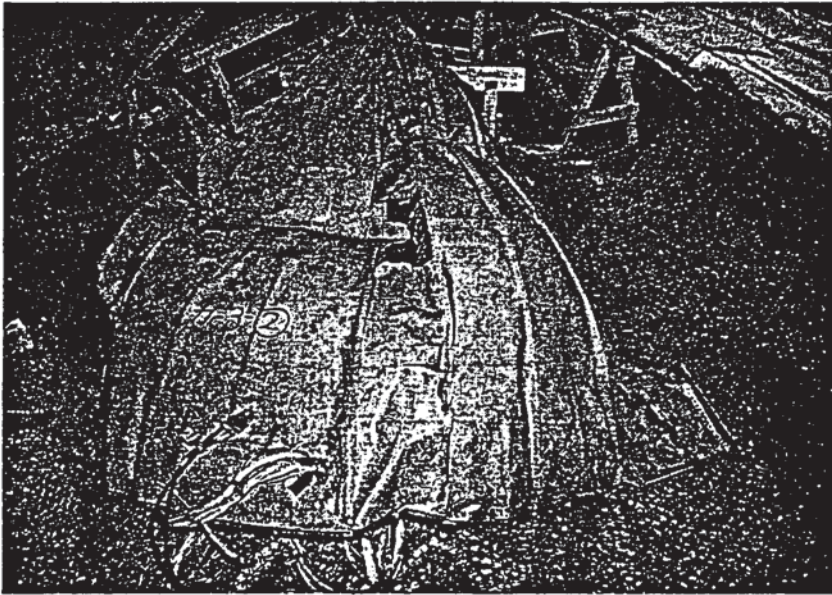
68 Aft pressure bulkhead part 2A (pressurized side)

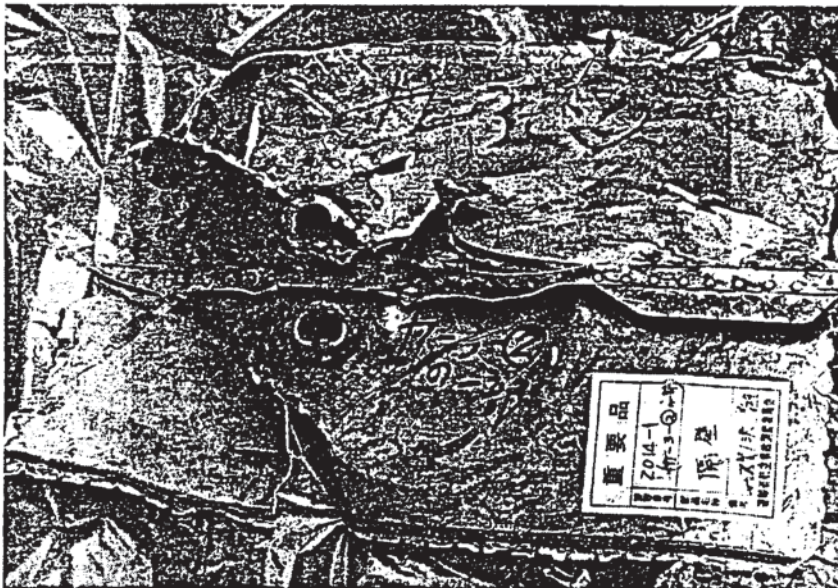
69 Aft pressure bulkhead part 2A (nonpressurized side)

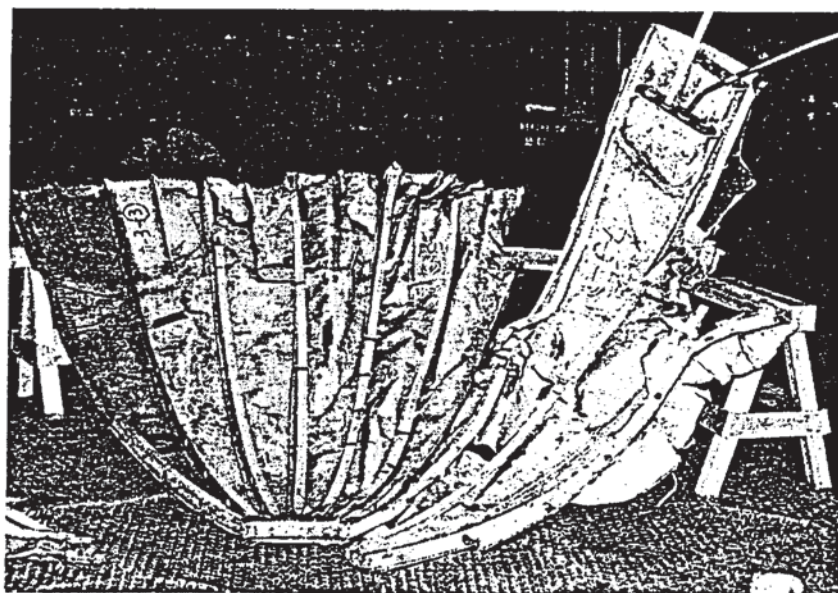
71 Aft pressure bulkhead part 3 (nonpressurized side)

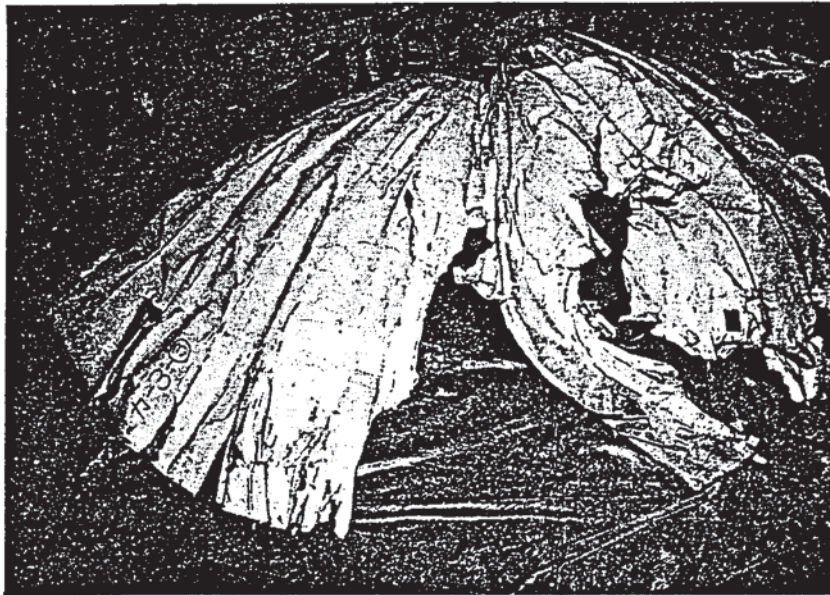
72 Aft pressure bulkhead part 4 (pressurized side)

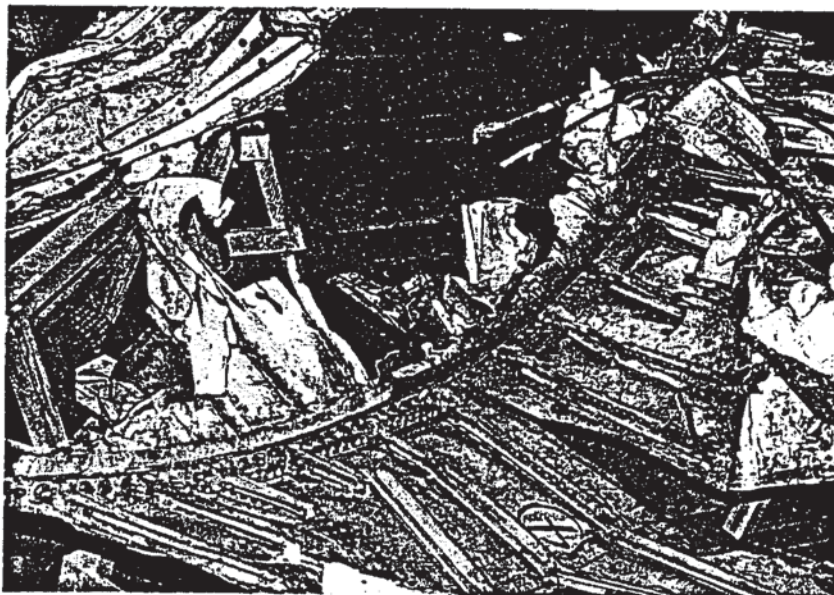
73 Aft pressure bulkhead part 5 (pressurized side)

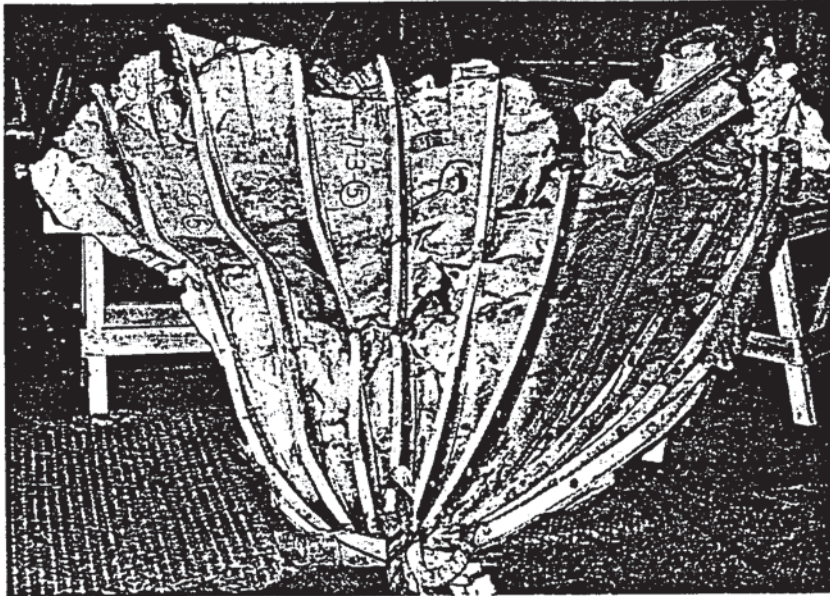
74 Aft pressure bulkhead part 5 (nonpressurized side)

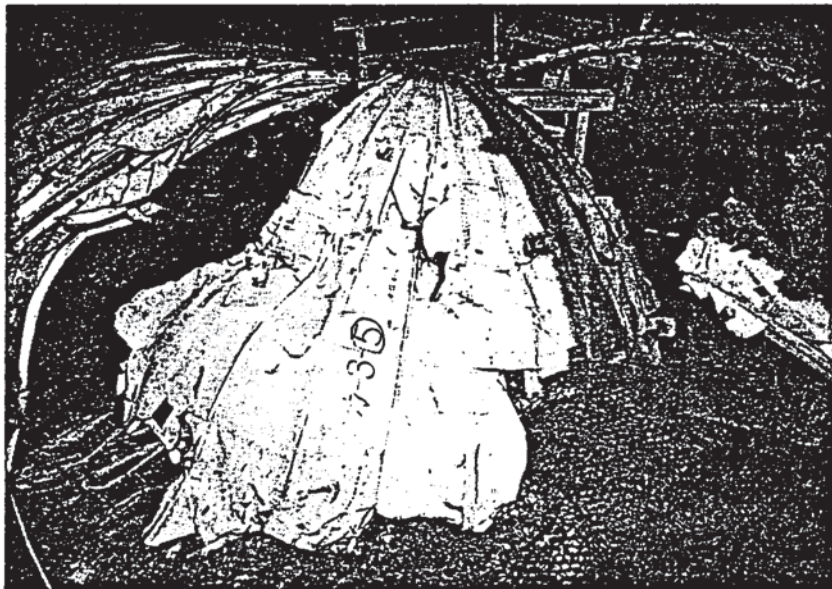
75 Aft pressure bulkhead part 6 (pressurized side)

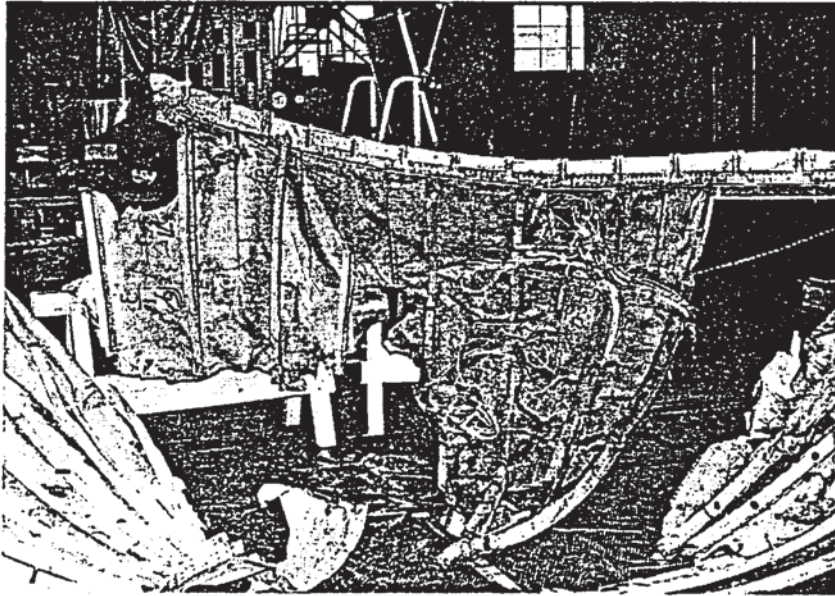
76 Aft pressure bulkhead part 6 (nonpressurized side)

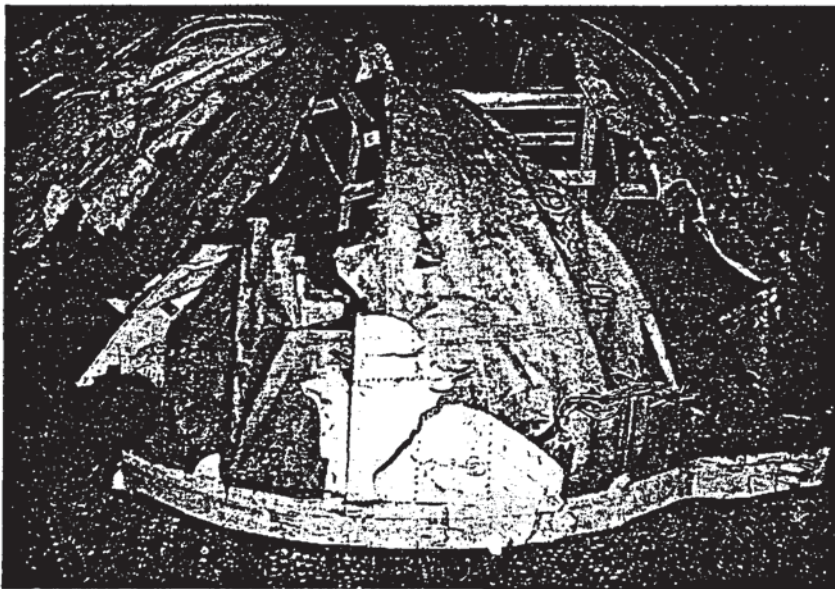
77 Buckling of aft pressure bulkhead (1)

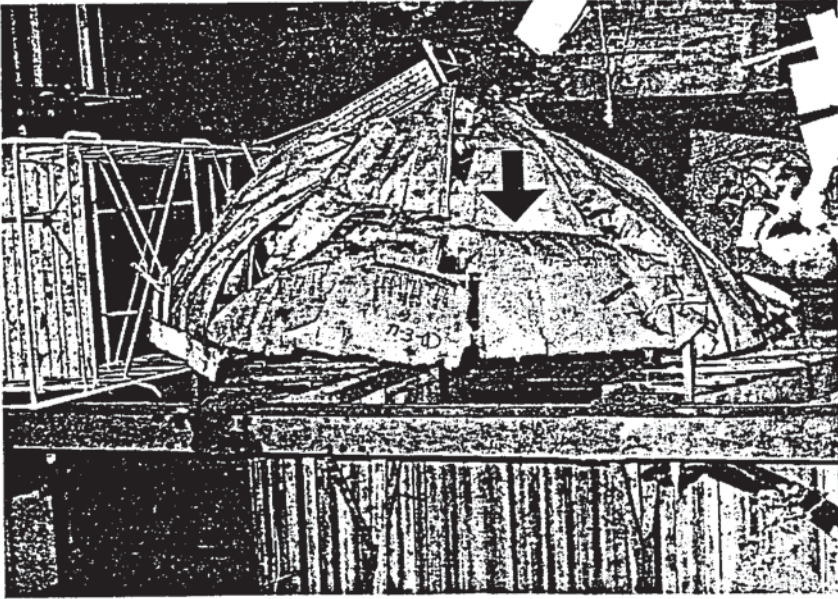
78 Buckling of aft pressure bulkhead (2)

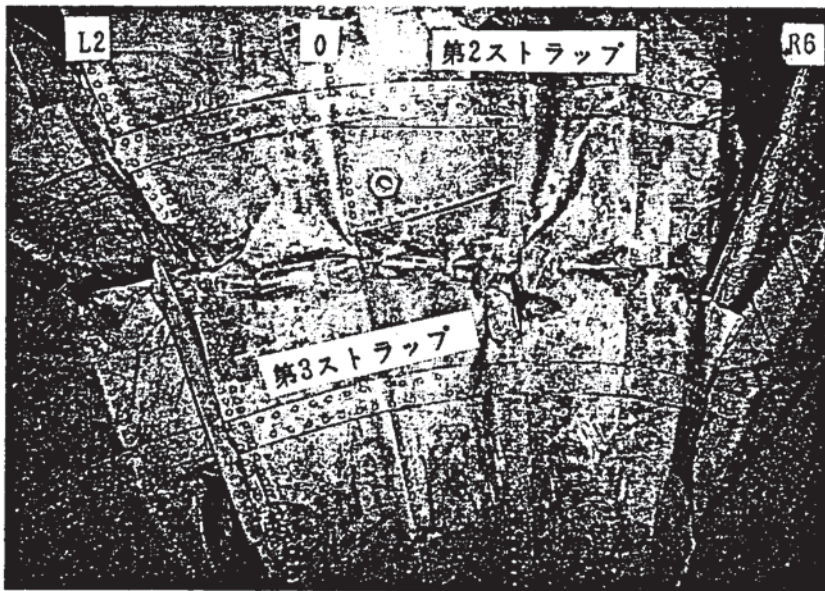
79 Buckling of aft pressure bulkhead (3)

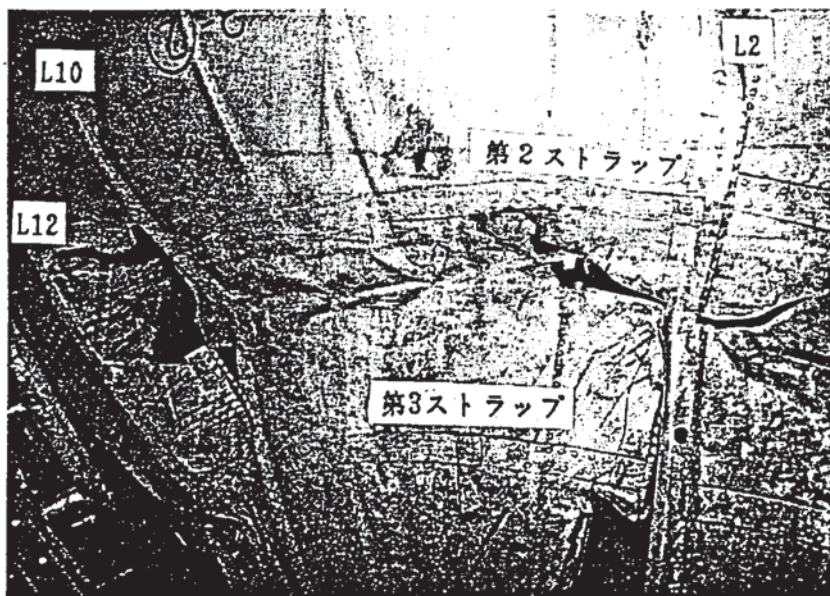
80 Buckling of aft pressure bulkhead (4)

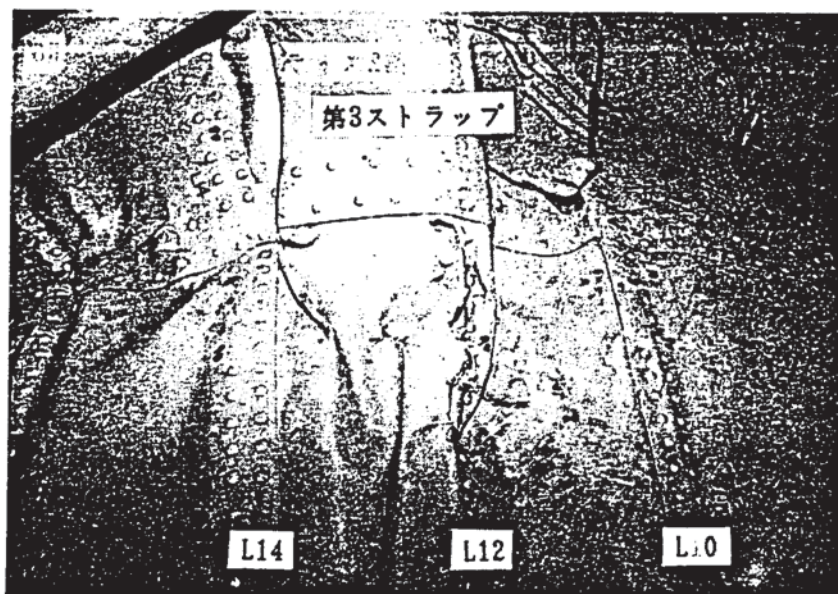
81 Buckling of aft pressure bulkhead (5)

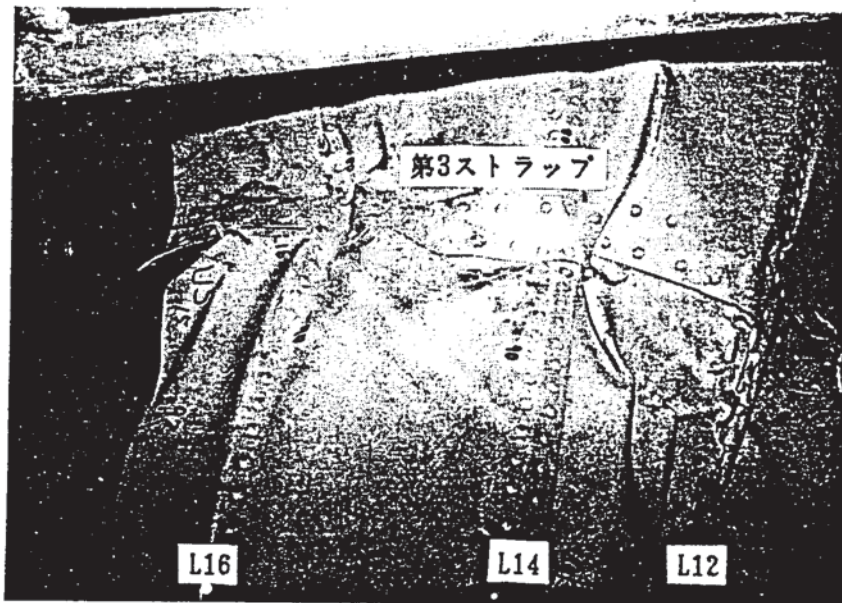
82 Buckling of aft pressure bulkhead (6)

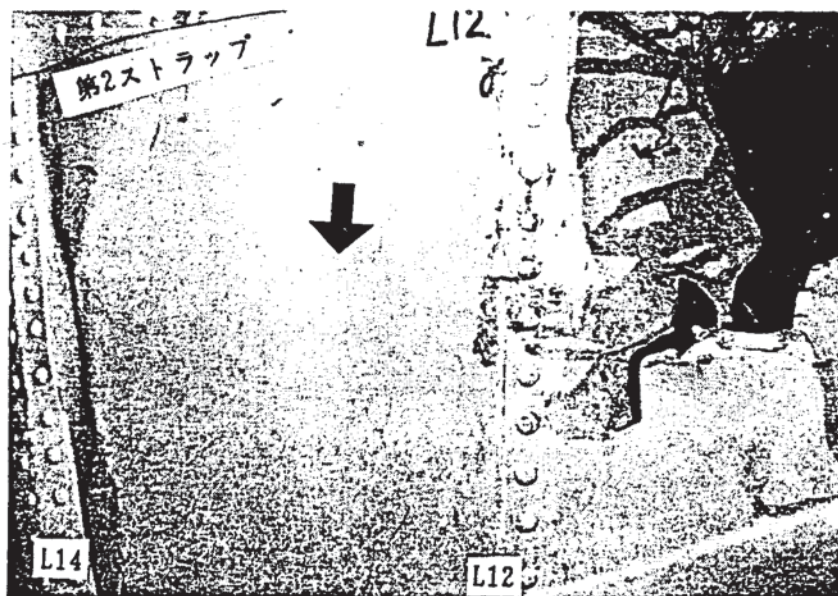
83 Buckling of aft pressure bulkhead (7)

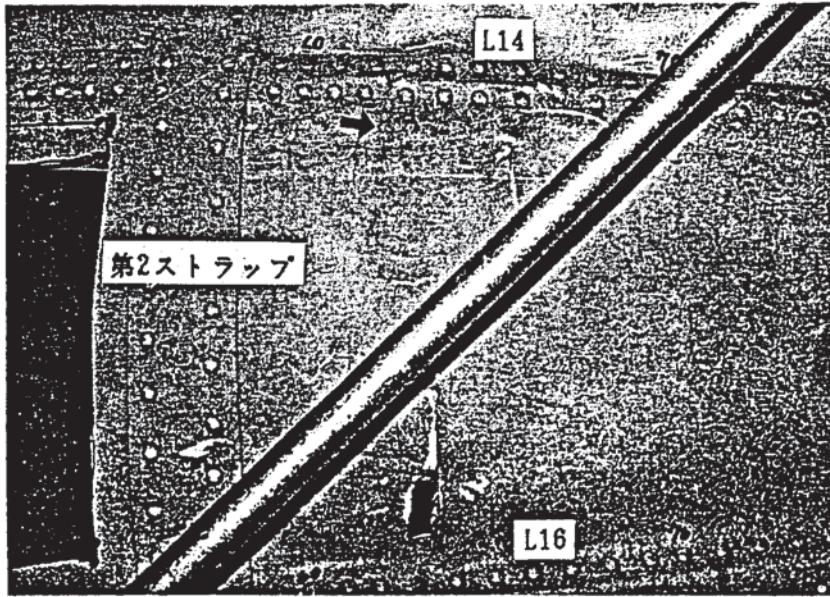
84 Aft pressure bulkhead L18 splice-lower web edge

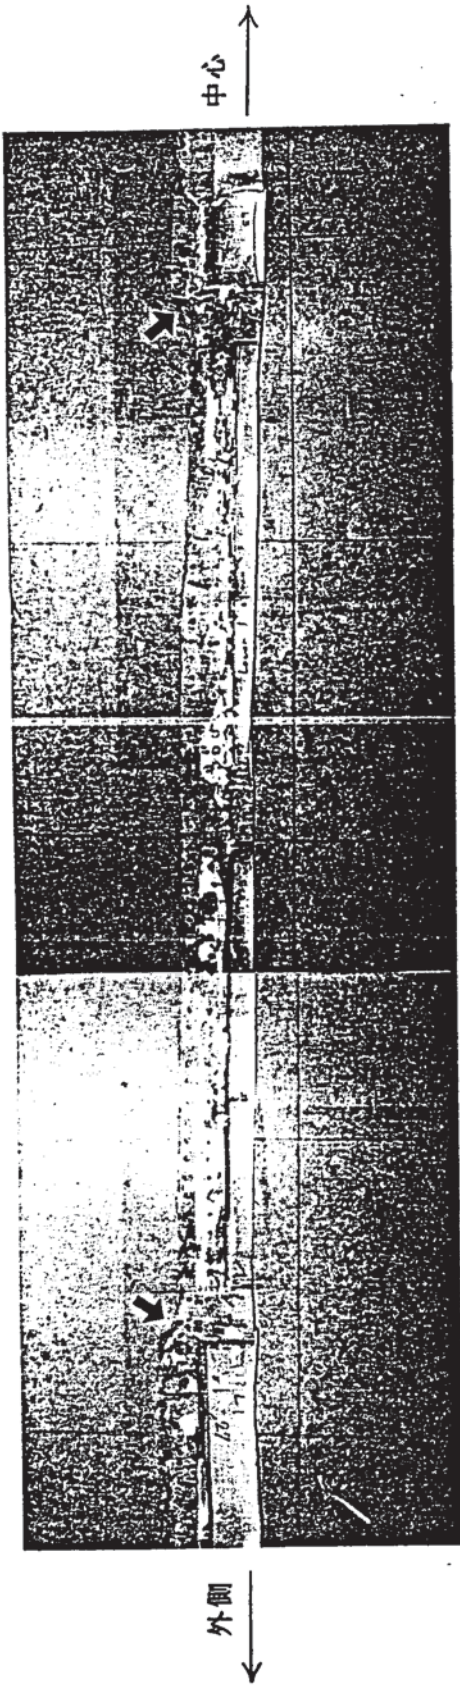
86 Aft pressure bulkhead L18 splice-edge distance in vicinity of rivet No.84

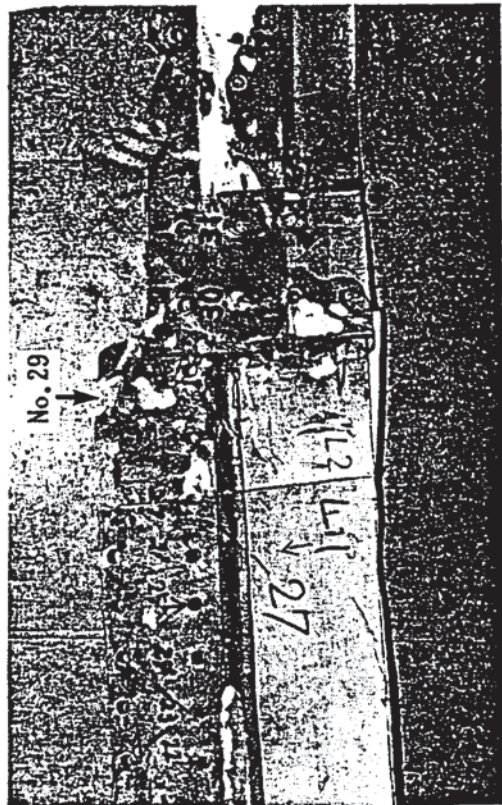
87 Aft pressure bulkhead L18 splice-adherence of tobacco nicotine in vicinity of rivet No.21 to No.24

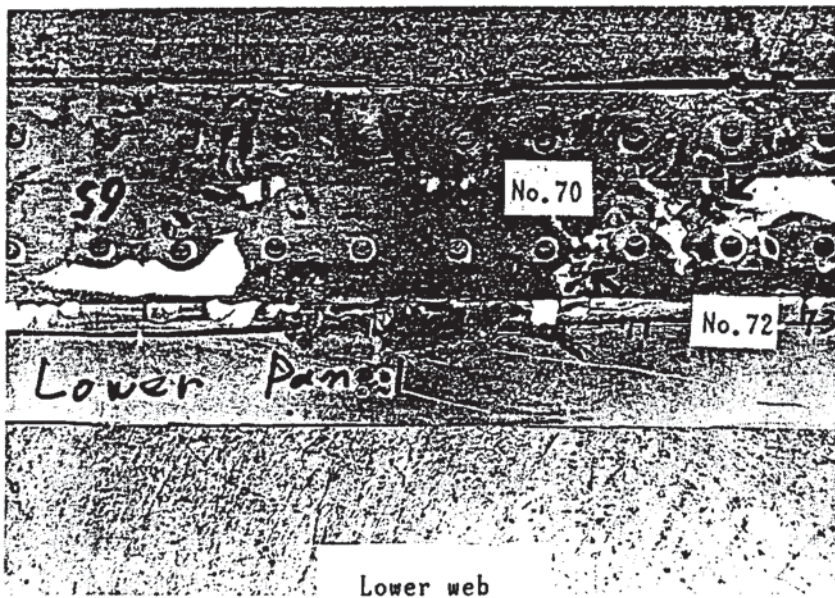
91 Aft pressure bulkhead L18 splice-adherence of tobacco
nicotine in vicinity of rivet No.75 to No.78

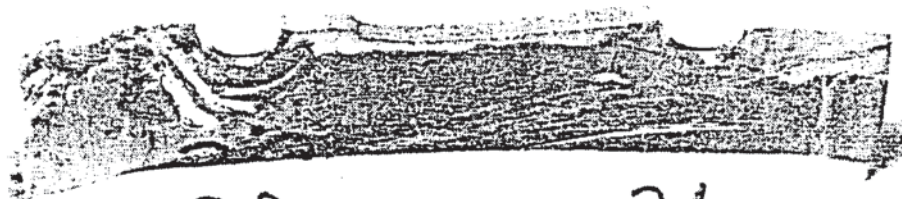
As shown in enlarged views in Photo-112 to Photo-115, the fracture surface of the straps is inclined about 45 degrees in the direction of thickness and the fracture is considered as resulting from tension due to overload.

Photo-115 Fracture aspect of No.1 strap. Lower fragment of the upper strap, aft view.

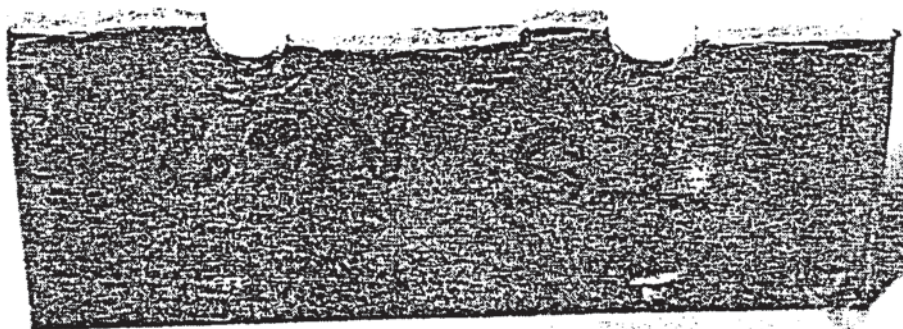
Photo-116 Fracture aspect of No.2 strap. Lower fragment of the upper strap, aft view.

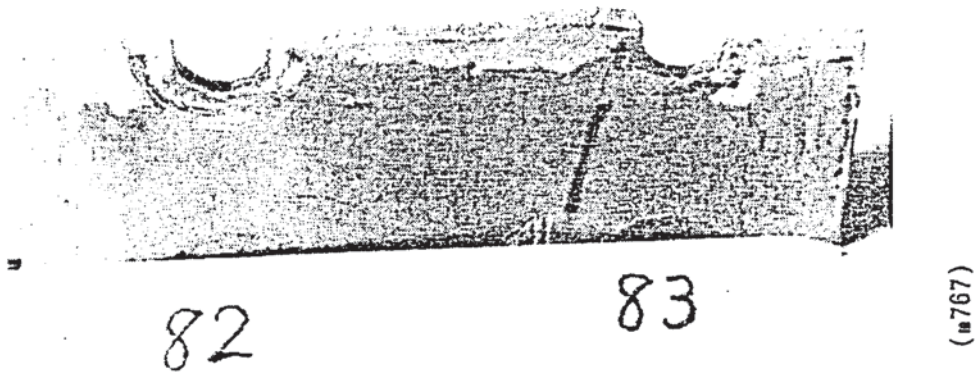
Photo-117 Fracture aspect of No.3 strap. Lower fragment of the upper strap, aft view.

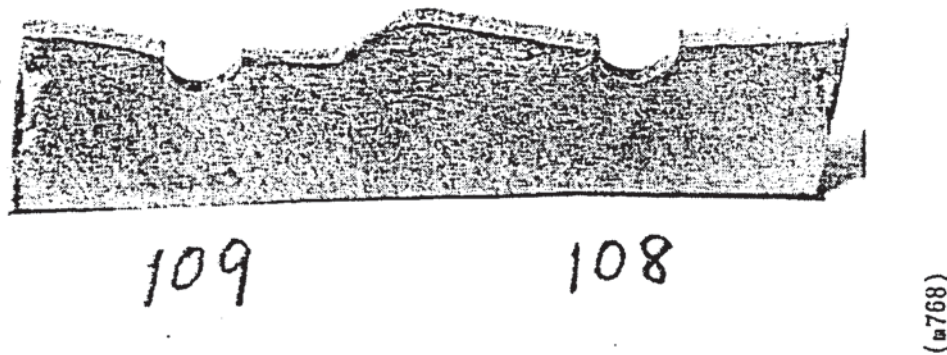
Photo-118 Fracture aspect of No.4 strap. Lower fragment of the upper strap, front view.

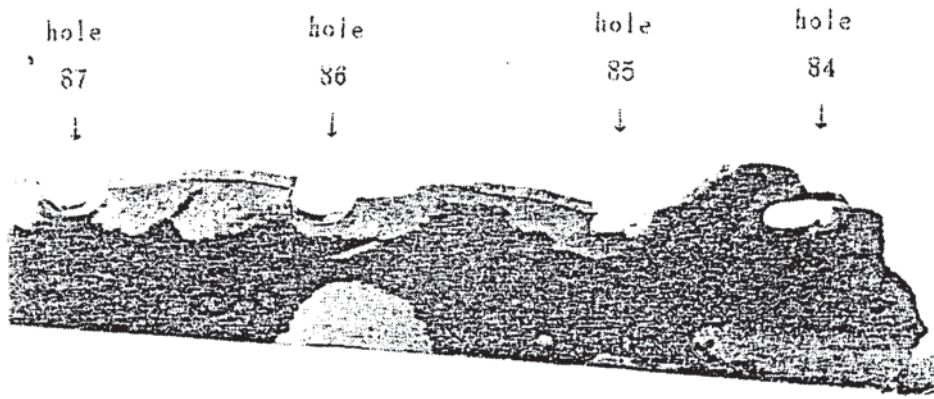
The sole fracture through rivet hole 84 to 89 of the lower web along L18 stiffener is also recognized as due to tension by overload as can be seen in Photo-123.

Photo-123 A part of failure line in lower web through rivet holes 84-89.
Observation of upper fragment, aft view.

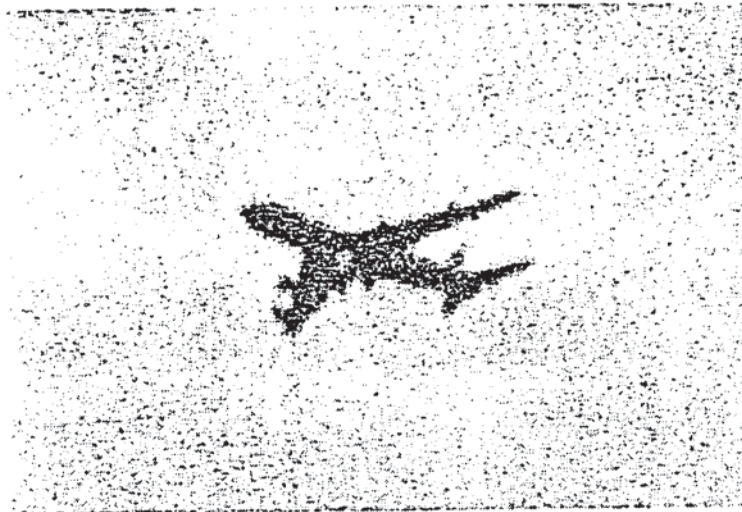
An analysis was made on the status of damage to the vertical fin of the accident aircraft, based on a photograph taken from the ground of the aircraft flying over Okutama City, Nishitama County, Tokyo at about 1850 hours, August 12. Data used were the photograph of the aircraft (see Attached Photo-124), a model of Boeing, and the damage chart of the vertical fin (see Attached Figure-27 and -28).

Photo-124 The accident aircraft flying over Okutama.

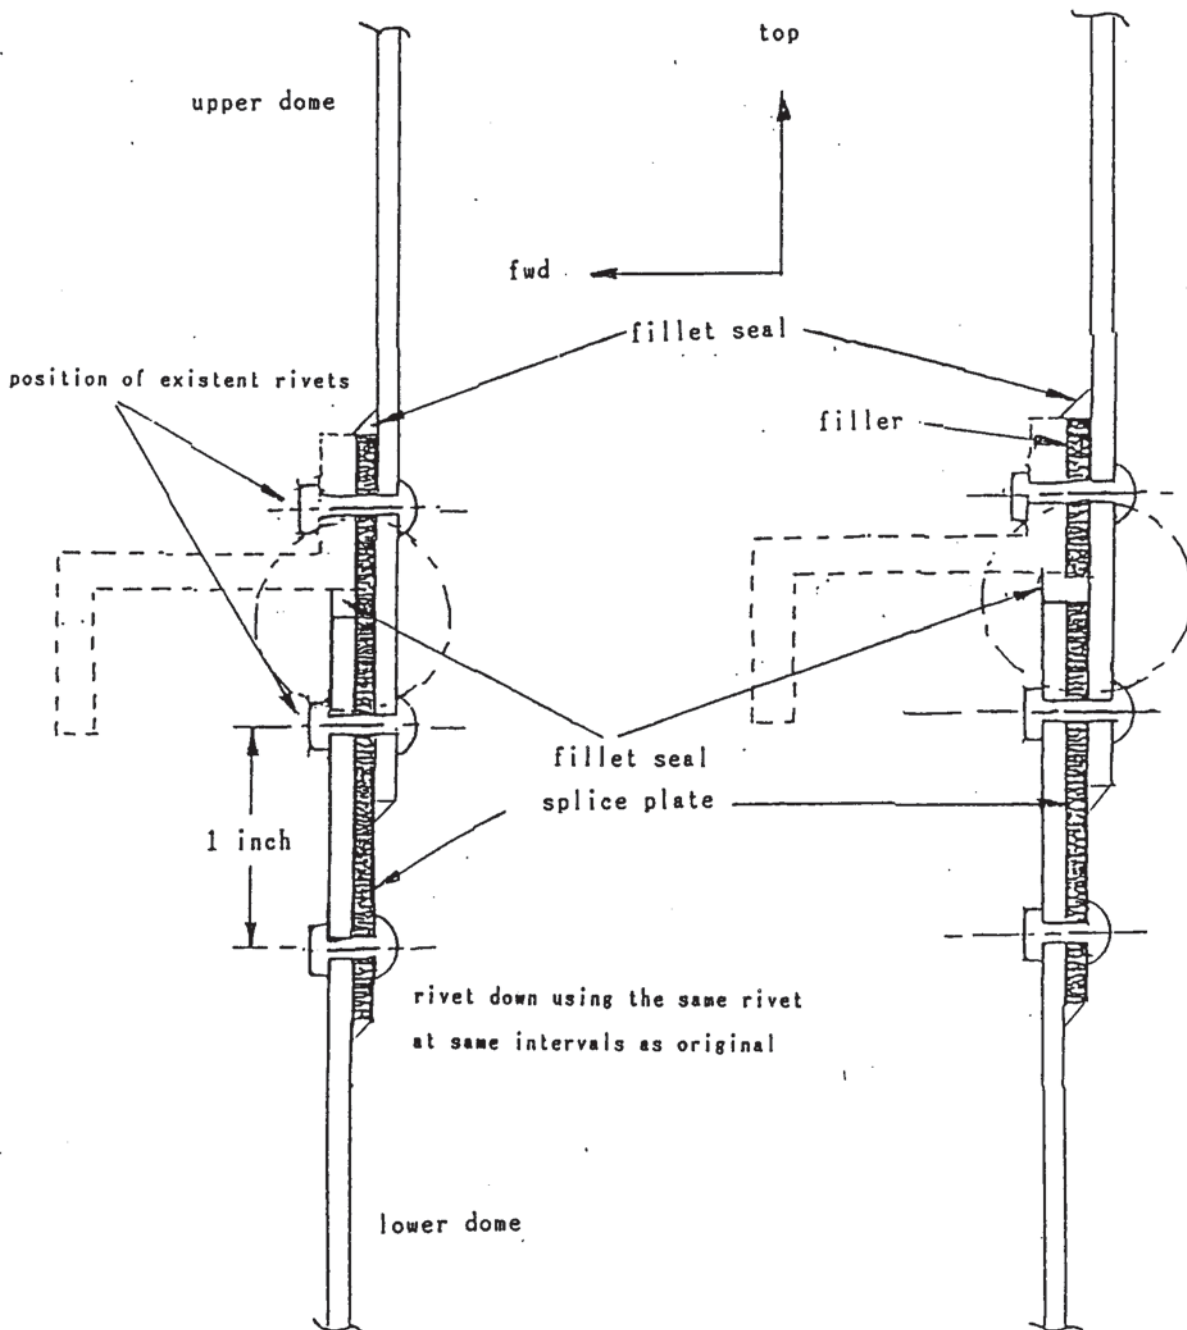
the way to joint instructed
 in the corrective measure

junction actually practiced

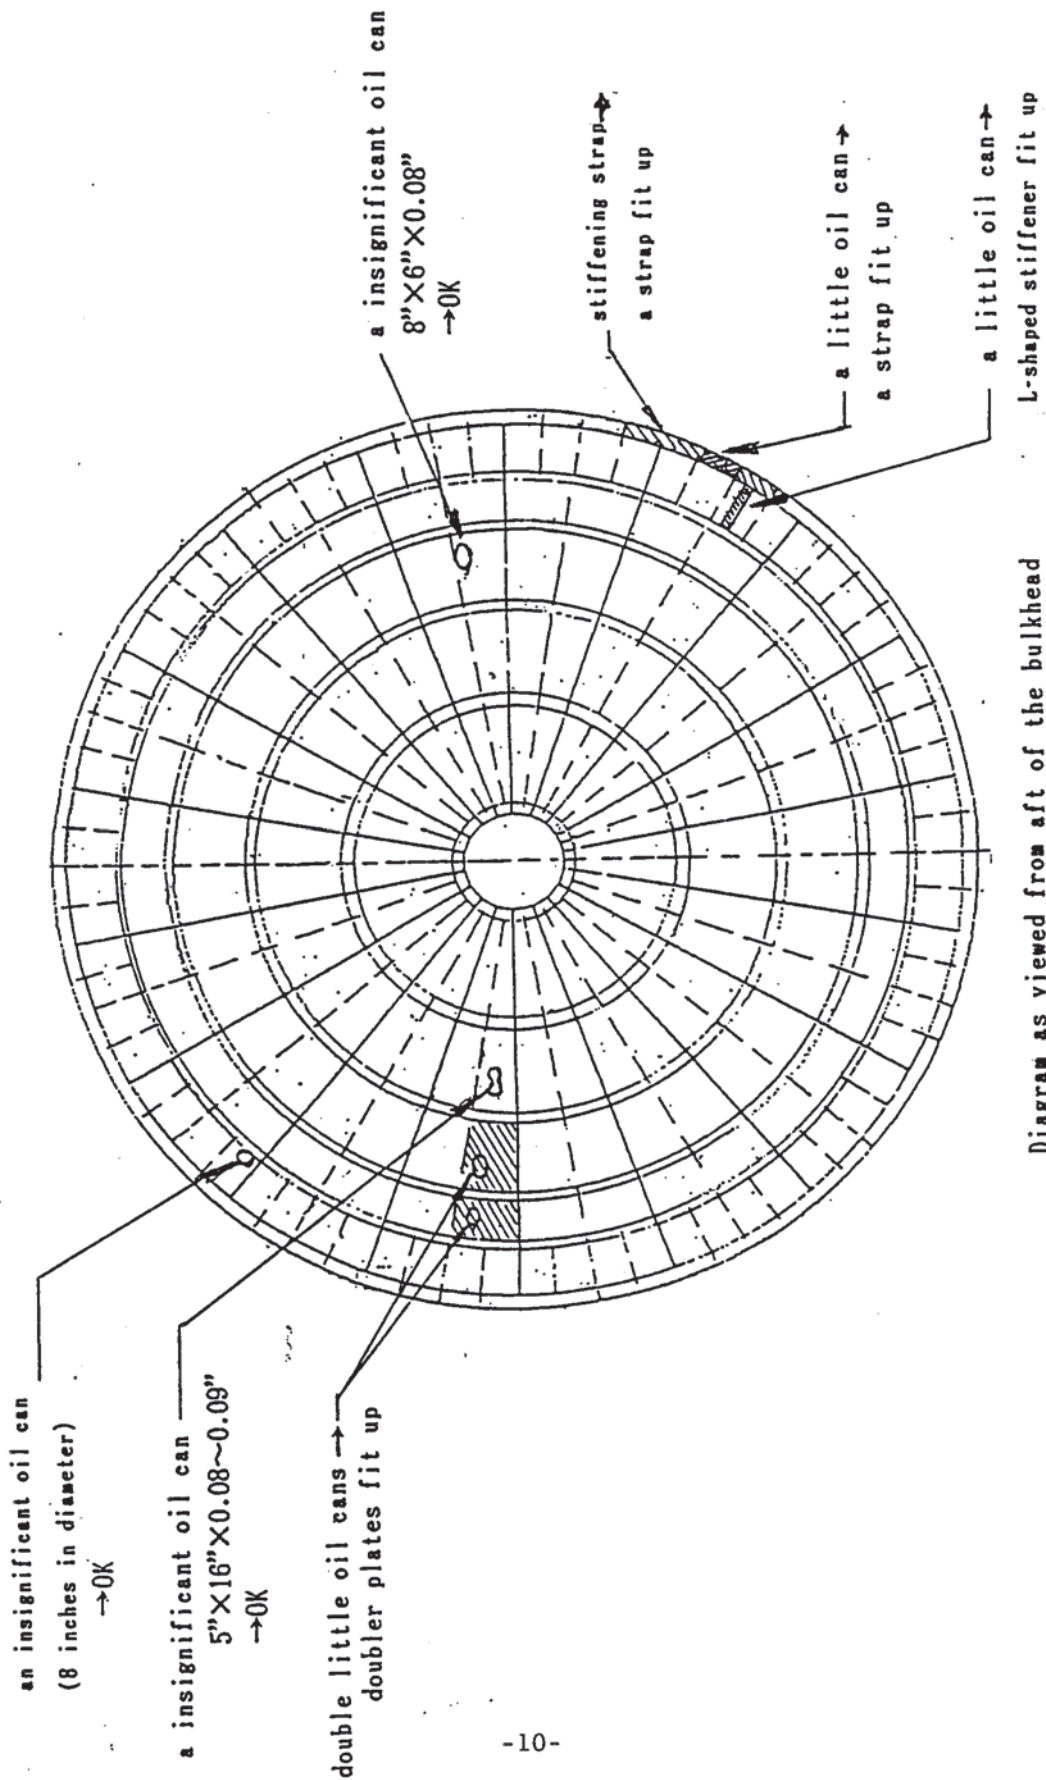
Attachment 1 Attached Figure - 4 Treatment of Web Oil Cans

(8) In the inspection by the inspector of the repair team, oil canning was discovered at six locations on webs of the aft pressure bulkhead, as shown in Attached Figure-4 of Attachment 1, out of which three were within the allowance of the 747 Structure Repair Manual, but on the other three the following repairs were conducted:

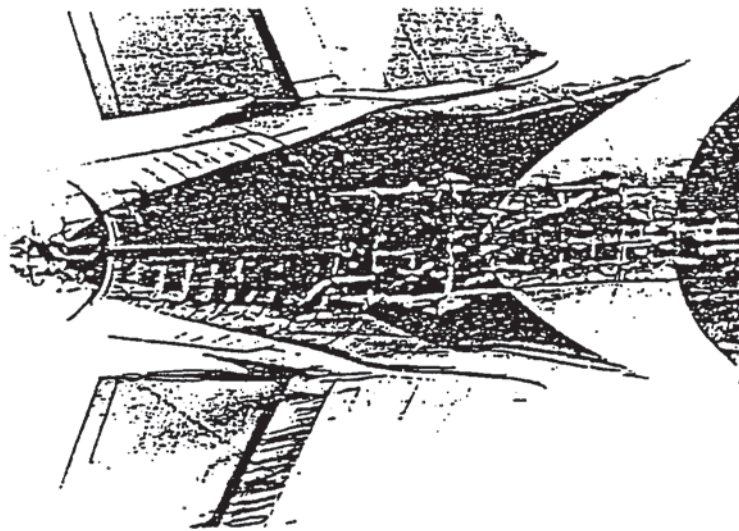
(see Photo-1 and -2, and Attached Figure-1 and -2, of Attachment 1)

Attachment 1 Photo-1
Under surface of the empennage

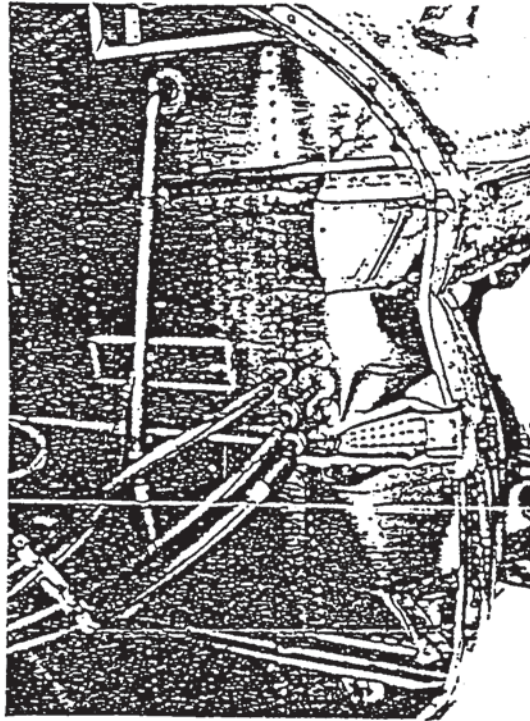
Attachment 1 Photo-2
Lower portion of the APU firewall
